SITE & BUILDING CONSTRUCTION EVALUATION

Section 1 Site Access

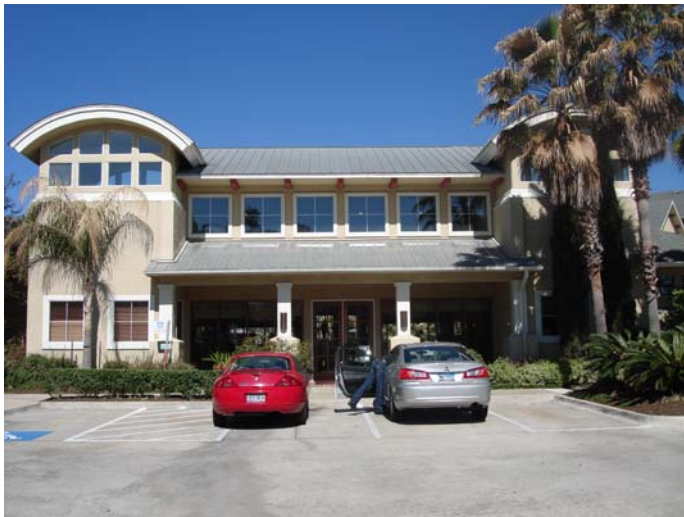
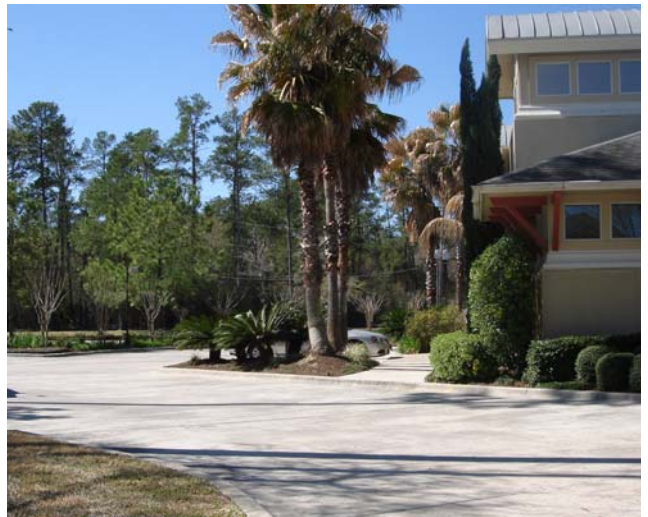
There were no sidewalks extending to the street or to a public sidewalk at the complex.

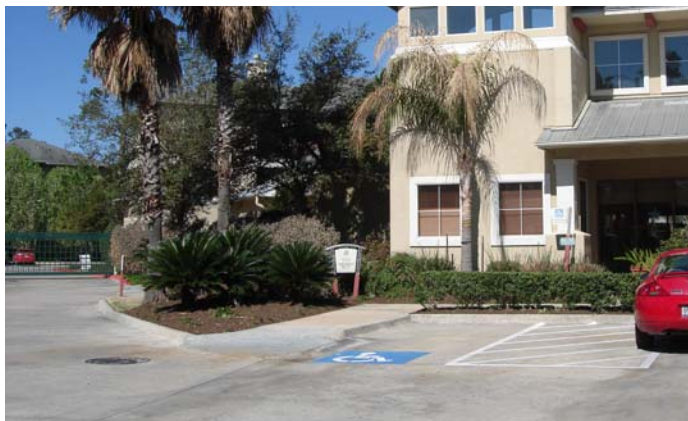
Curb ramp & access aisle (#0941 at front)

The only curb free access from the street and parking lot to the leasing office entrance and to the rent drop slot required use of the curb ramp located adjacent to the parking area in front. This curb ramp connected directly to the vehicular lane.

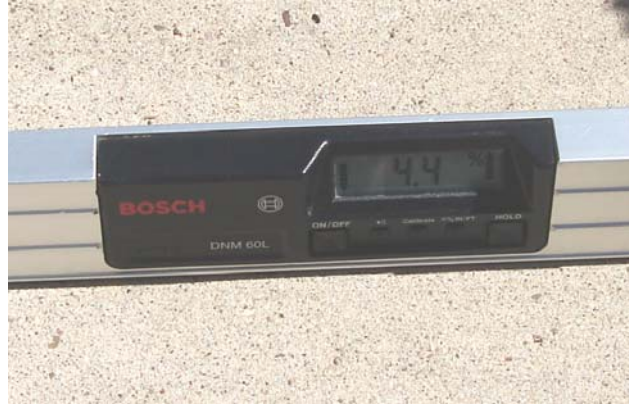
From the curb ramp, there was no accessible route to the front entry provided. The landing where the sidewalk turns 90 degrees had a cross slope of 5.0% in one direction (2% maximum allowable), the sidewalk had cross slopes up to 4.4% (2.0% maximum allowable) and the curb ramp had a cross slope of 5.7% (2.0% maximum allowable) and the curb ramp lacked required detectable warnings (ANSI 4.7.2, 4.8.2 and 4.27).

Cross slope at landing (#0919), above

Cross slope at sidewalk (#0923), above right

Cross slope at curb ramp (#0928), right

All curb ramps on site must comply with the requirements of ANSI 4.7 Curb Ramps and 4.27 Detectable Warnings.

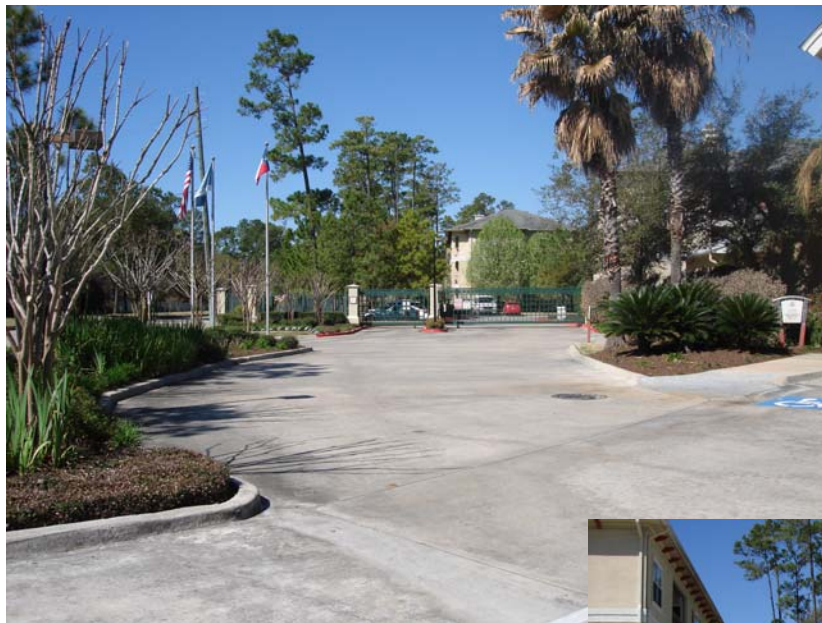
No sidewalks were provided within the interior of the site to connect buildings and amenities. The entries to the residential portion of the site was gated and designed for vehicular use only. (FHAG, Requirement 2)

Entry to Residential Areas (#0939), left

Side entry to residential area (#0987), below

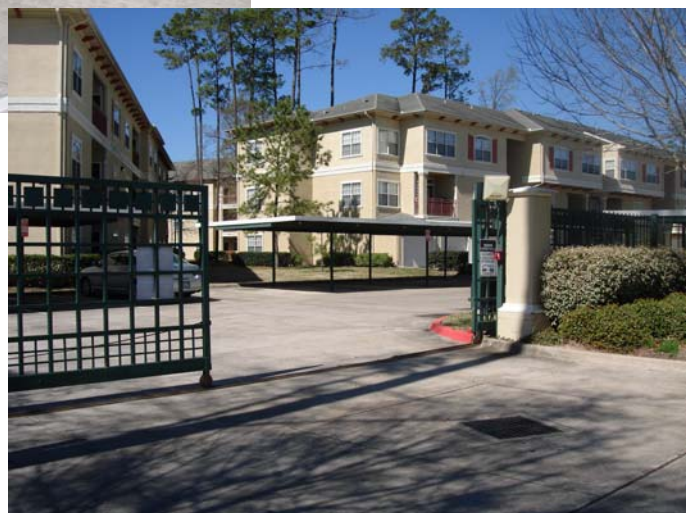
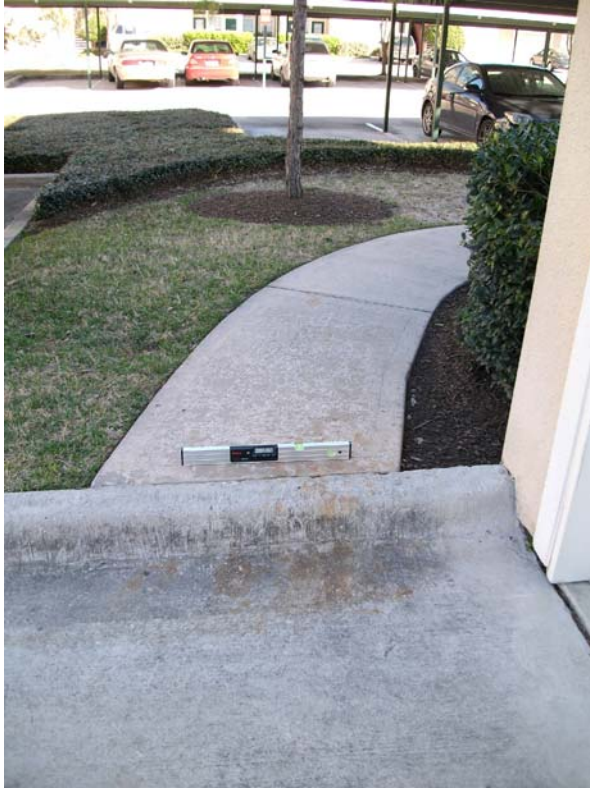
Between the pool area and Buildings #2 and #3, there were sidewalks. However, neither was accessible. The sidewalk serving Building 2 ended in a curb and a parking space at one end and had cross slopes greater than the 2% permitted (4.5%). "Nowhere shall the cross slope of an accessible route exceed 1:50." (ANSI 4.3.7).

Curb at Building #2 Sidewalk (#S0460), left

Cross slope at Building #2 Sidewalk (#S0467), below

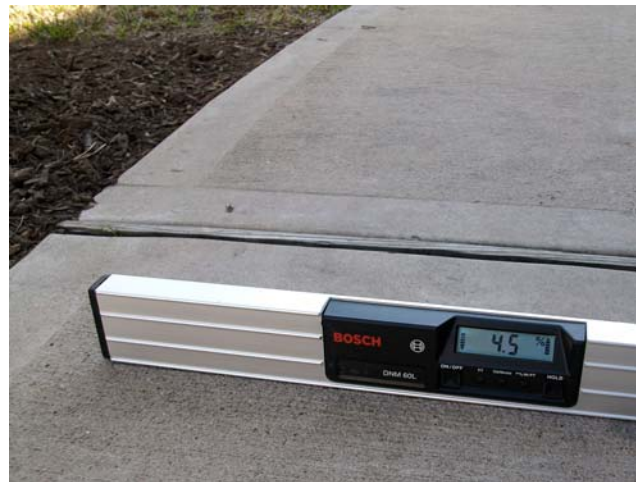
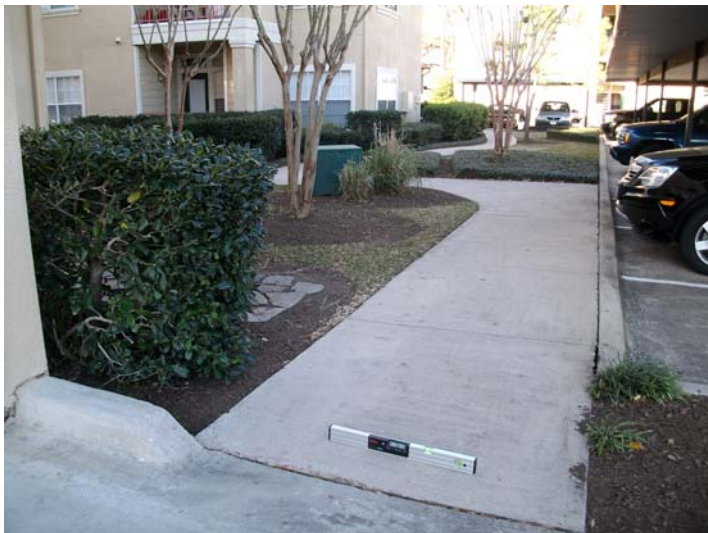
This sidewalk connected to a sidewalk at Building #3 which was not accessible. The walk had cross slopes greater than 2% (3.6%) and it dead ended into the side of a parking space which could be blocked by a car.

End of walk at Building #3 (#S0389)

Cross slope at Building #3 Sidewalk (#S0390), below

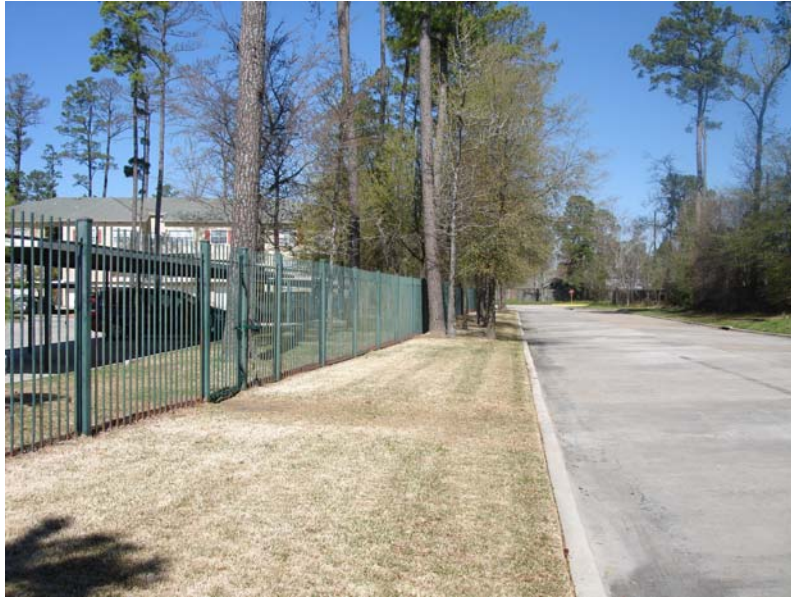
*School bus stop (#0990), left
Gate at school bus stop ((#0991),
below*

The school bus serving the complex stopped daily on Compaq Drive. Children were dropped at a grassy area and passed through a side gate to a carport/parking area and to a vehicular lane. No accessible route was provided in any portion of this pathway.

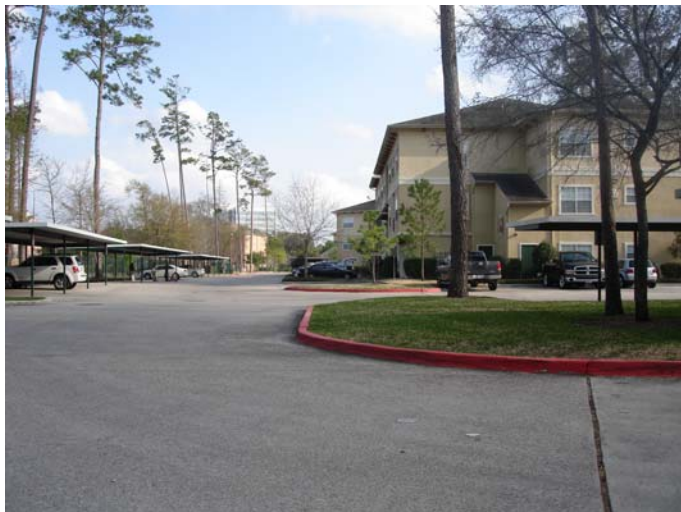
Drive with carports (#0256)

Within the residential portion of the complex, the driving lane was clearly marked with fire lane stripes which are generally immediately adjacent to a curb or to parking spaces. Pedestrian accessible routes were not provided.

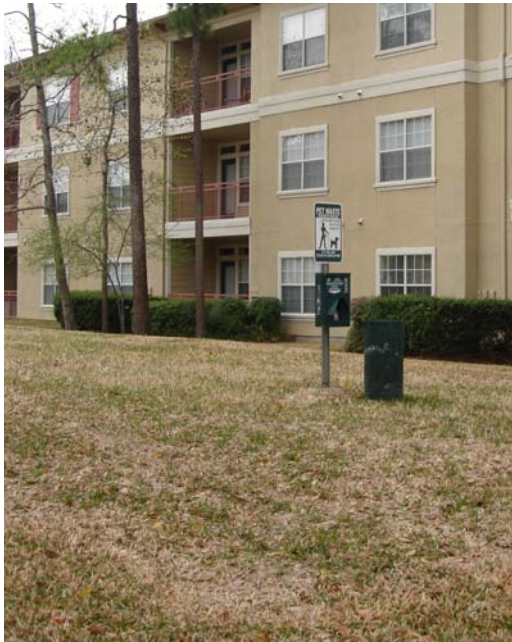
Pet Post (#9672)

No accessible routes were provided to dog owner trash and bag dispenser poles.

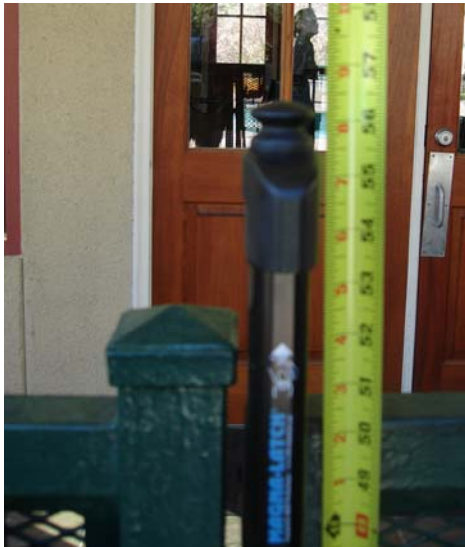
Gate at Game Room (#0877)

The pool enclosure was gated at several locations. The gates had a variety of latching mechanisms and typically had spring hinges that required more than 8.5 pounds of force to open. ANSI 4.13.11 limits the maximum force for pushing or pulling open a door to 8.5 lbf at exterior locations.

The gate to the game room had a pull up latch with the operable parts mounted above the 48 inches permitted for forward reach range (55-3/4 inches measured) (ANSI 4.2.5). A forward reach would be required in order to approach the gate, operate the hardware and then pass through to the other side.

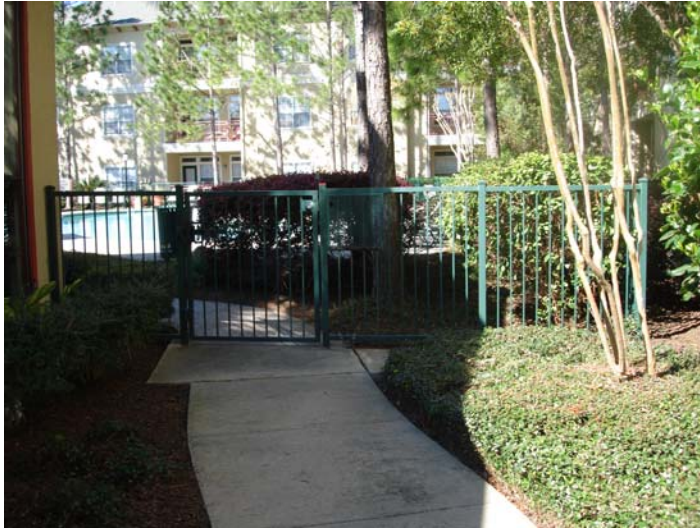
*Gate to Bldg. 3 (#0882), above
Gate Latch at Bldg. 3 Gate (#0880), right*

A gate leading to sidewalk at the back of Building #3 had a pull latch mounted at 55-1/2 inches (54 inches maximum permitted). The gate also had a double cylinder dead bolt which was not locked. If this lock is used, operating the lock would require a pinching and twisting motion and the gate would not be accessible (ANSI 4.13.9).

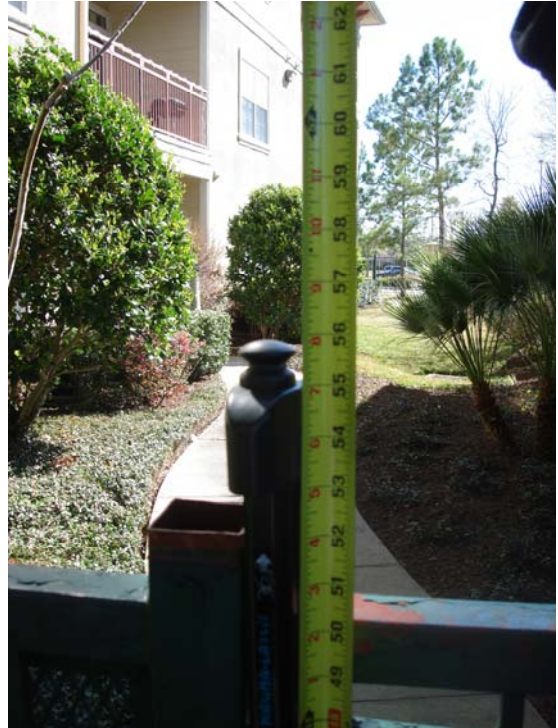
Gate at the Fitness Center (#0885)

The gate at the fitness center had a push up latch which required that the user push up and pull forward simultaneously. To operate the latch from the fitness room side, the user had to reach over the gate to pull up the latch on the pool side and then push the gate forward. The top of the gate was at 51 inches above the concrete and 12 inch required approach area on the pull side was not provided (8 inches) (ANSI 4.13.6). The force required to operate the gate was 9 pounds which is more than the 8.5 pounds permitted in exterior locations (ANSI 4.13.11).

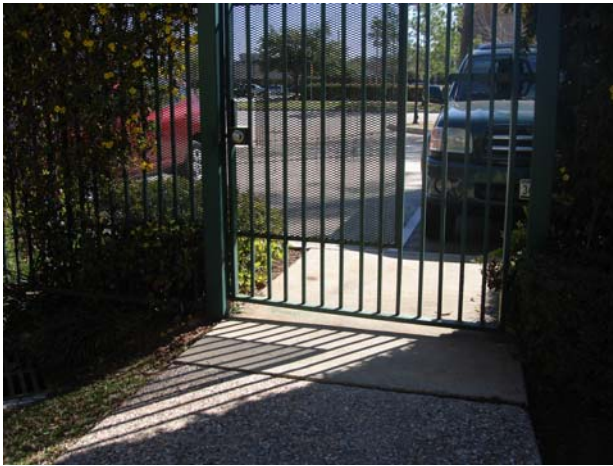
Gate at parking area (#0889)

A gate to the parking lot was open and in use during my site visit. The gate had a double sided deadbolt. If this lock is used, the motion to operate the lock would require a pinching and twisting motion and the gate would not be accessible (ANSI 4.13.9). In addition, no approach space was provided on either side of the gate. Clear approach spaces are required on both sides of doors with closers and latches. (ANSI 4.13.6).

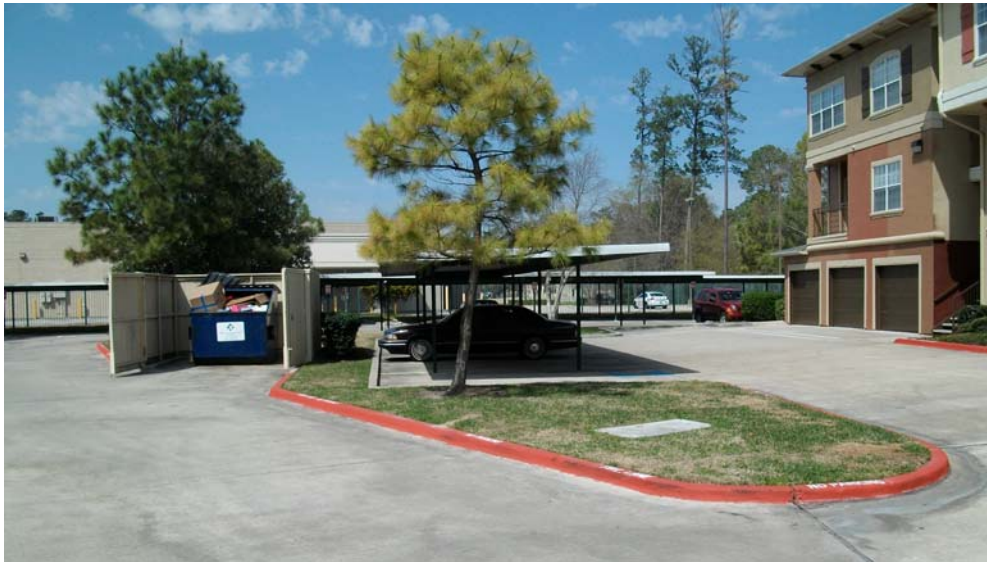
*Trash Enclosure
by Building 8
(#S0139)*

Trash for the complex was gathered at four dumpster facilities located in the parking areas of the complex. No sidewalks or accessible routes connected to these facilities. Access to the enclosures was from the parking area and vehicular drives. The dumpsters are located at the parking island between Buildings 7 and 8; by the mail building; at the parking island between Buildings 10 and 12; and between Buildings 13 and 15.

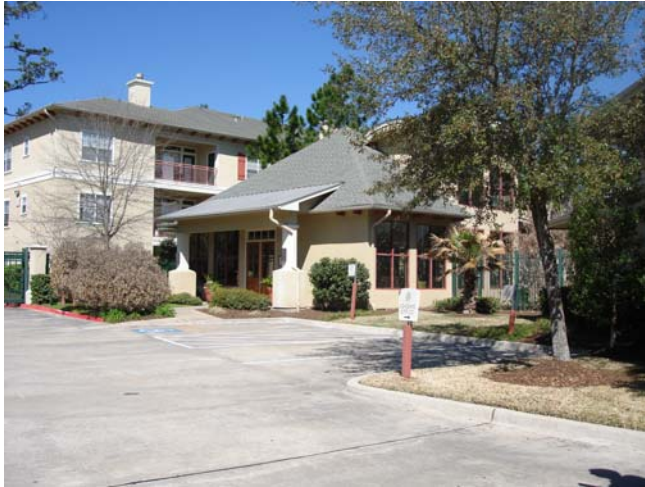
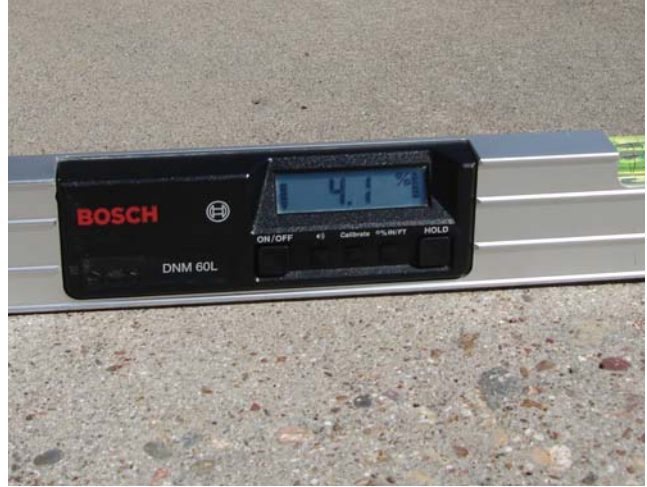
Game Room Building - from Front Drive (#0945) Level at Sidewalk to Game Room (#0962)

At the front, the game room was typically locked. In addition, the entry and landing did not connect to an accessible route. The sidewalk from the front door connected to a sidewalk with cross slopes more than 2% (up to 4.1%). (ANSI 4..3.7).

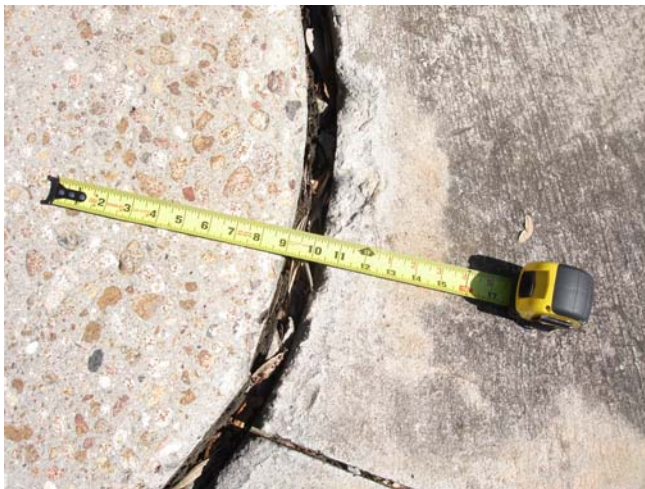
Gap at bottom of curb ramp (#0963)

At the connection to the parking lot, the curb ramp section of the sidewalk lacked required detectable warnings and had a gap in the surface of more than ½ inch (1-1/4 inch). (ANSI 4.5.4).

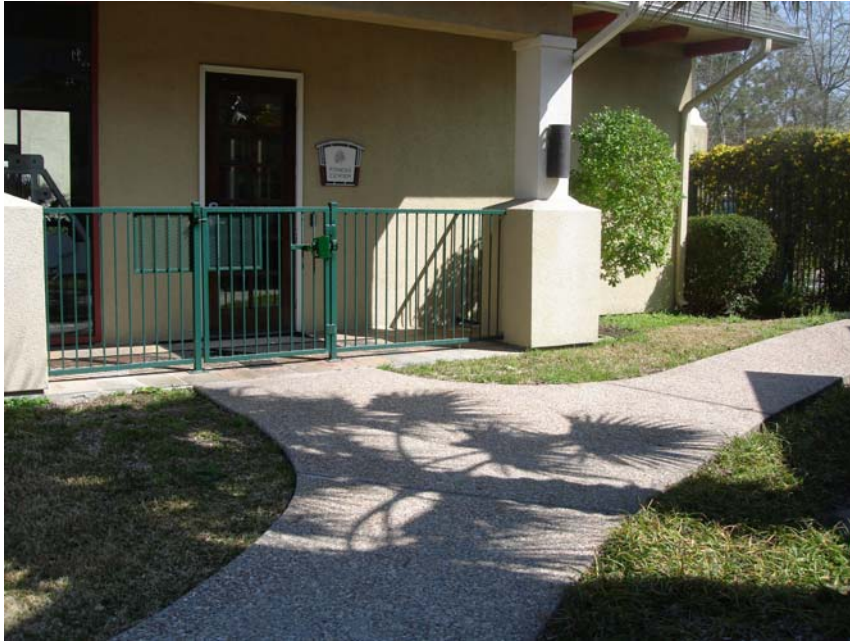
Fitness Center (#0526)

The fitness center could be reached from the pool area (see above sections) or through a gate by a side parking area. Neither the pool area nor the parking lot gate were on an accessible route to any of the residential buildings.

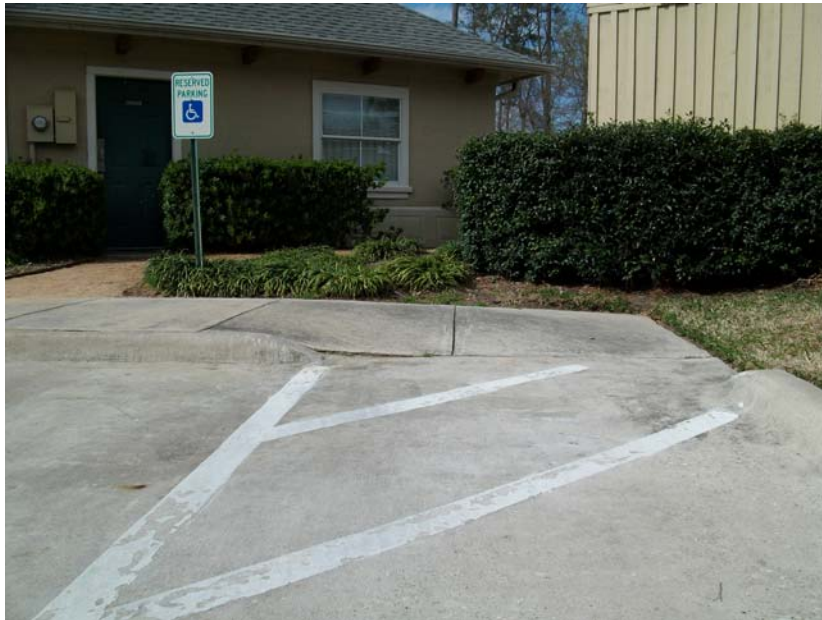
There were no accessible routes connecting to this island or serving this building. On the Building 3 side, there was one accessible parking space designated. The sidewalk between this parking space and the mail building was not accessible. The cross slopes at the landing at the end of the access aisle and the sidewalk connecting the mail building with the rest of the complex were greater than 2% (up to 5.1%) (ANSI 4.3.7). The running slope at the sidewalk to the landing had running slopes greater than 8.33% (10.8%) (ANSI 4.8.2).

*Running slope at sidewalk
(#0863), above left*

*Level at landing cross slope
(#0866), above right*

*Access aisle – sidewalk
connections (#S0341), left*

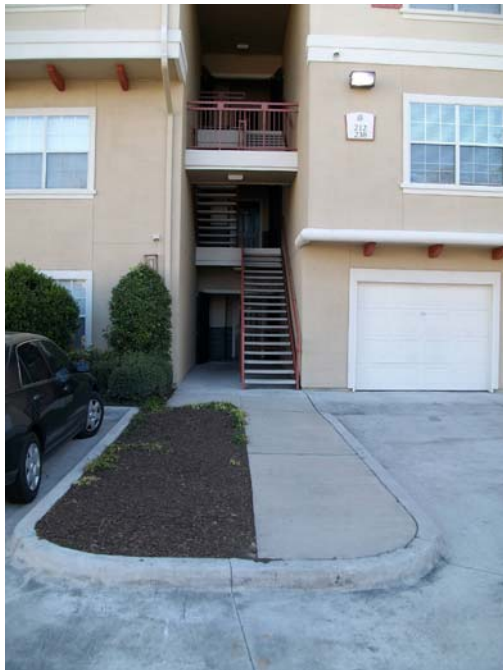
*Bldg 2, Right Breezeway (#S0426)
Level at sidewalk cross slope (#S0432)*

The right breezeway had a sidewalk that extended straight out to the drive lane and a curb. At one side, the sidewalk ended at the side of a parking space behind the garages. There was no detectable warning at the blended transition to the parking space nor was there a curb ramp or detectable warning at the curb at the vehicular lane. The cross slope on the sidewalk crossing in front of the stair and ending at the parking space was 4.2% which is greater than the 2% maximum allowed (ANSI 4.3.7).

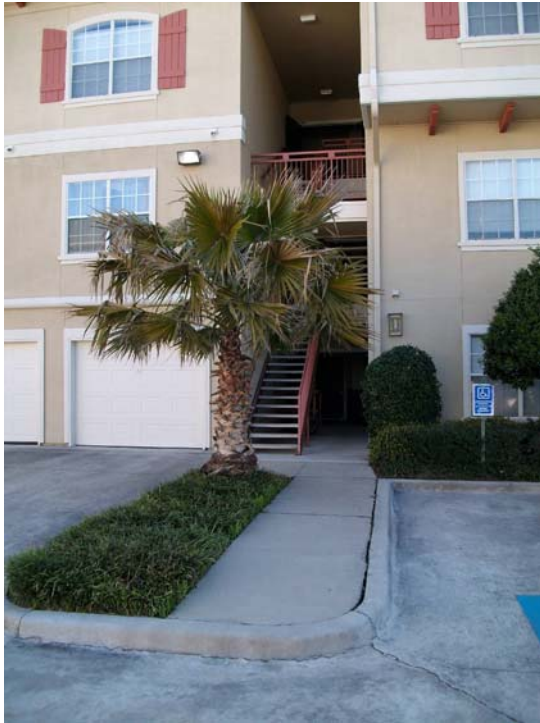
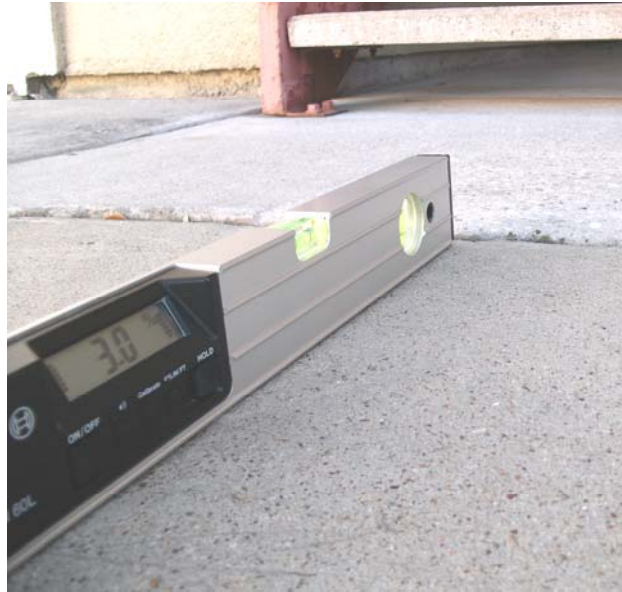
*Bldg 2, Left Breezeway Entry (#S0442)
Level at sidewalk cross slope (#S0447)*

The left breezeway had a sidewalk that extended straight out to the drive lane and a curb. At one side, the sidewalk ended at the side of a parking space behind the garages. There was no detectable warning at the blended transition to the parking space nor was there a curb ramp or detectable warning at the curb at the vehicular lane. The cross slope on the sidewalk crossing in front of the stair and ending at the parking space was 3% which is greater than the 2% maximum allowed (ANSI 4.3.7).

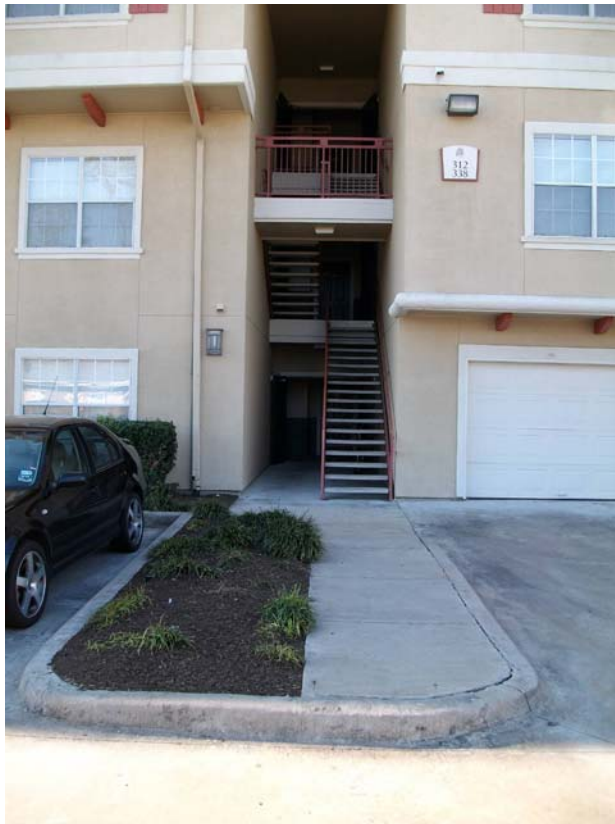
Bldg 3, Right Breezeway (#S0377)

The right breezeway had a sidewalk that extended straight out to the drive lane and a curb. At one side, the sidewalk ended at the side of a parking space behind the garages. There was no detectable warning at the blended transition to the parking space nor was there a curb ramp or detectable warning at the curb at the vehicular lane.

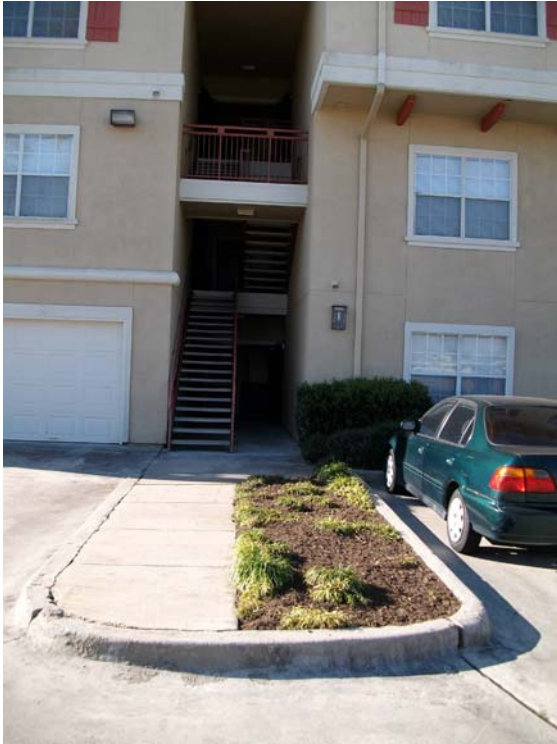
Bldg 3, Left Breezeway Entry (#S0409)

The left breezeway had a sidewalk that extended straight out to the drive lane and a curb. At one side, the sidewalk led to the side of a parking space behind the garages. There was no detectable warning at the blended transition to the parking space nor was there a curb ramp or detectable warning at the curb at the vehicular lane.

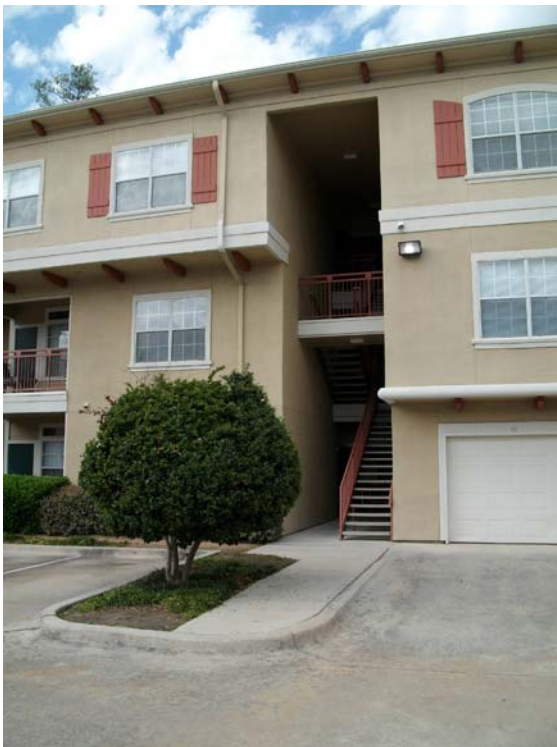
Bldg 4, Right Breezeway (#S0306)

The right breezeway had a sidewalk that extended straight out to the drive lane and a curb. At one side, the sidewalk led to a parking space behind the garages. There was no detectable warning at the blended transition to the parking space nor was there a curb ramp or detectable warning at the curb at the vehicular lane.

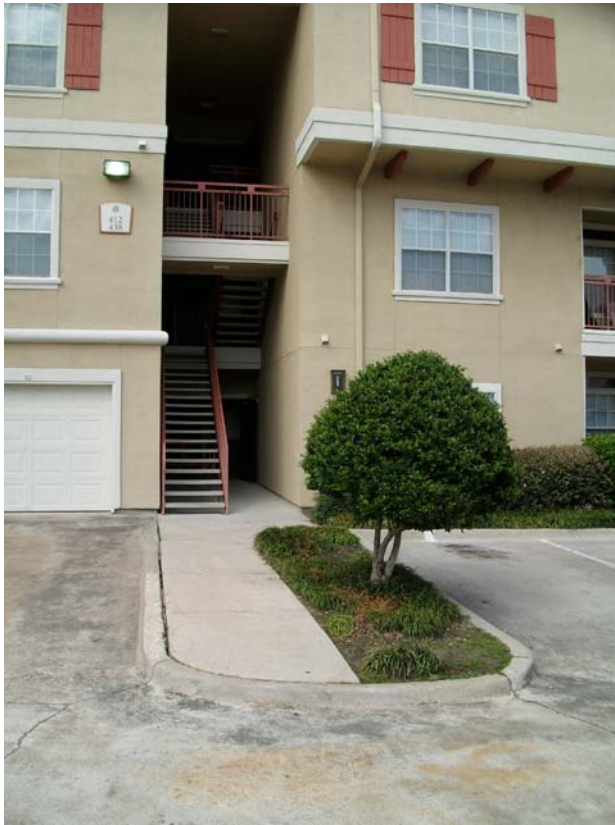
Bldg 4, Left Breezeway Entry (#S0288)

The left breezeway had a sidewalk that extended straight out to the drive lane and a curb. At one side, the sidewalk led a parking space behind the garages. There was no detectable warning at the blended transition to the parking space nor was there a curb ramp or detectable warning at the curb at the vehicular lane.

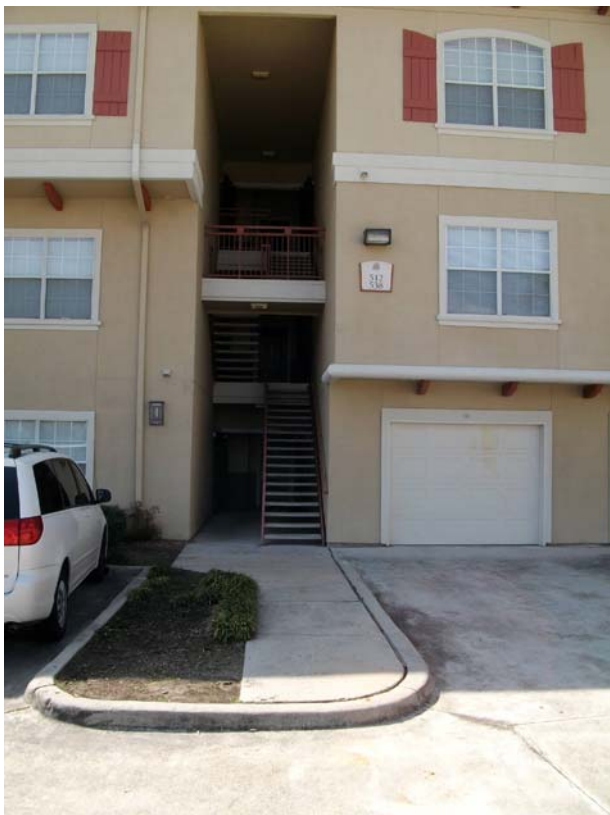
Bldg 5, Right Breezeway (#S0247)

The right breezeway had a sidewalk that extended straight out to the drive lane and a curb. At one side, the sidewalk led to a parking space behind the garages. There was no detectable warning at the blended transition to the parking space nor was there a curb ramp or detectable warning at the curb at the vehicular lane.

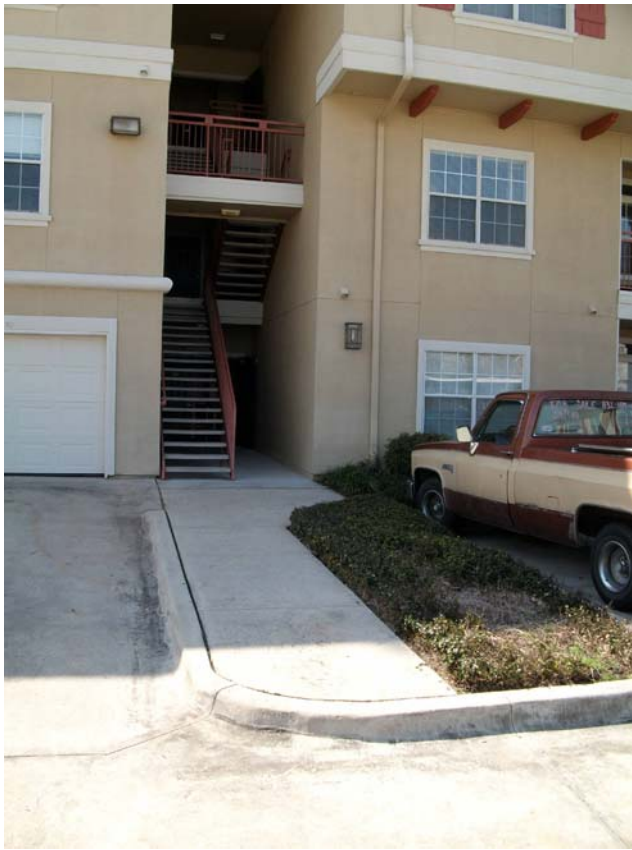
Bldg 5, Left Breezeway Entry (#S0268)

The left breezeway had a sidewalk that extended straight out to the drive lane and a curb. At one side, the sidewalk led to a parking space behind the garages. There was no detectable warning at the blended transition to the parking space nor was there a curb ramp or detectable warning at the curb at the vehicular lane.

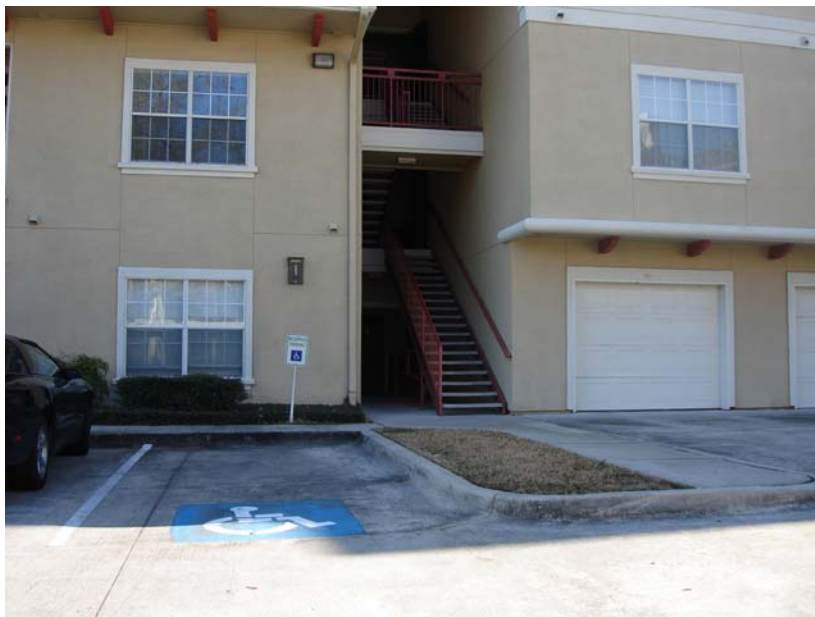
Bldg 6, Right Breezeway (#0801)

The right breezeway had a sidewalk that extended straight out to the drive lane and a curb. At one side, the sidewalk ended at a parking behind the garages. There was no detectable warning at the blended transition to the parking space nor was there a curb ramp or detectable warning at the curb at the vehicular lane.

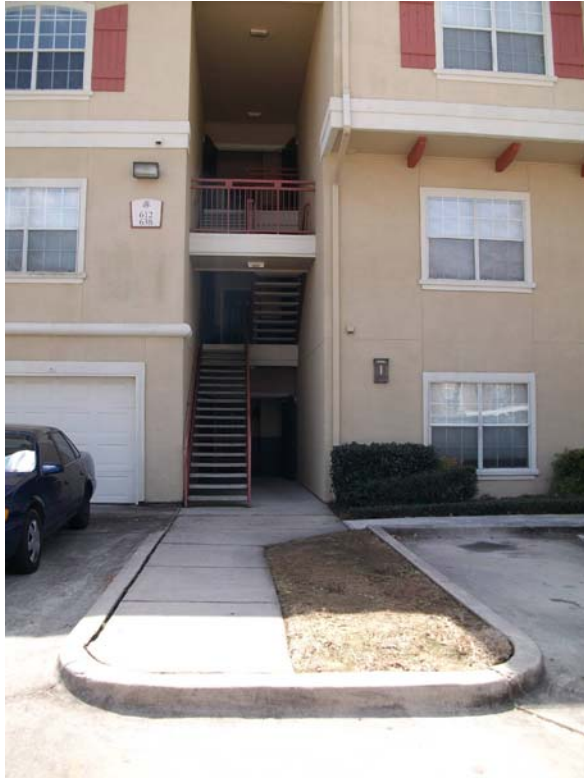
Bldg 6, Left Breezeway Entry (#S0195)

The left breezeway had a sidewalk that extended straight out to the drive lane and a curb. At one side, the sidewalk ended at a parking space behind the garages. There was no detectable warning at the blended transition to the parking space nor was there a curb ramp or detectable warning at the curb at the vehicular lane.

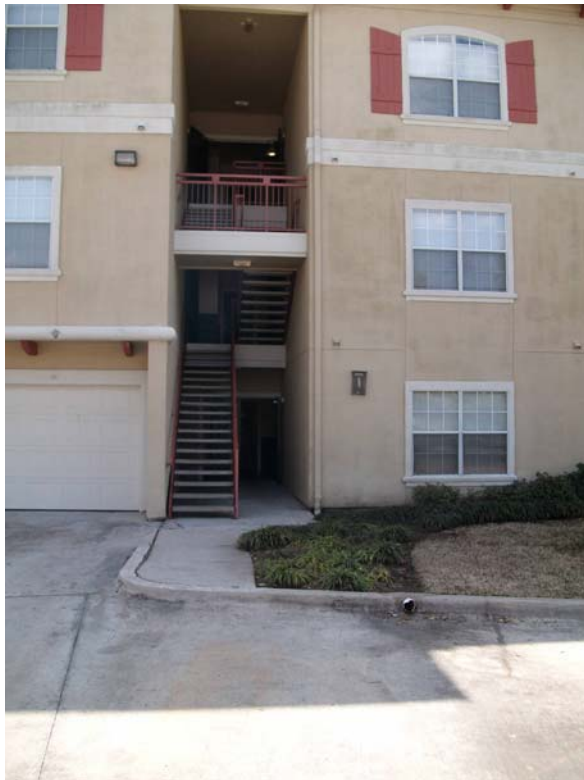
Bldg 7, Right Breezeway (#S0175)

The right breezeway had a sidewalk that extended straight out to the drive lane and a curb. At one side, the sidewalk ended at a parking space behind the garages. There was no detectable warning at the blended transition to the parking space nor was there a curb ramp or detectable warning at the curb at the vehicular lane.

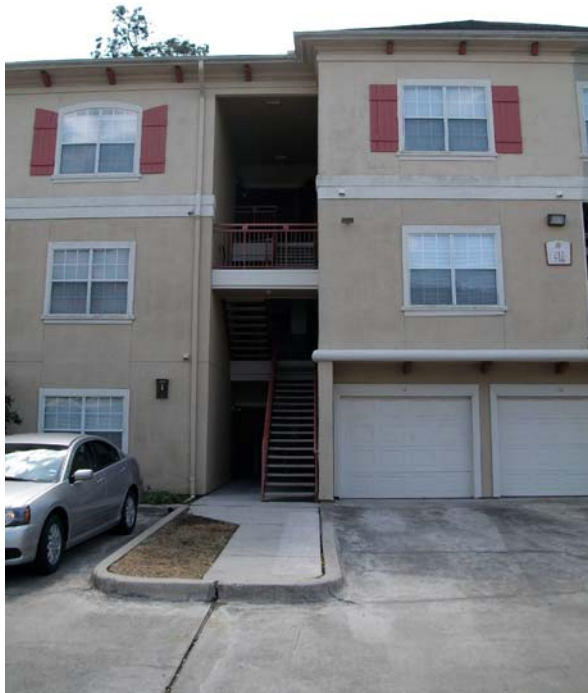
Bldg 7, Left Breezeway Entry (#S0166)

The left breezeway had a sidewalk that extended straight out to the drive lane and a curb. At one side, the sidewalk ended at a parking space behind the garages. There was no detectable warning at the blended transition to the parking space nor was there a curb ramp or detectable warning at the curb at the vehicular lane.

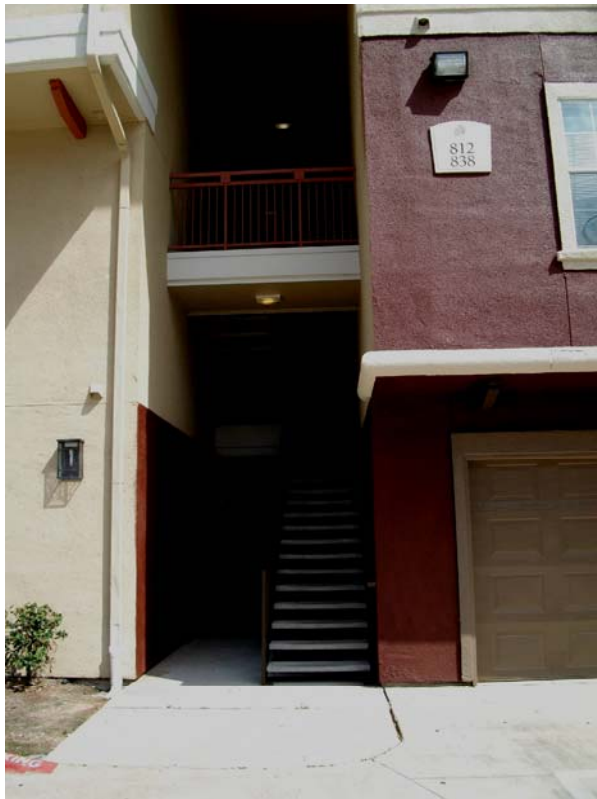
Bldg 8, Right Breezeway (#S0130)

The right breezeway had a sidewalk that extended straight out to the drive lane and opened on the right to a parking space behind the garages. There was no curb ramp or detectable warning at the blended transition to the parking space or to the vehicular lane.

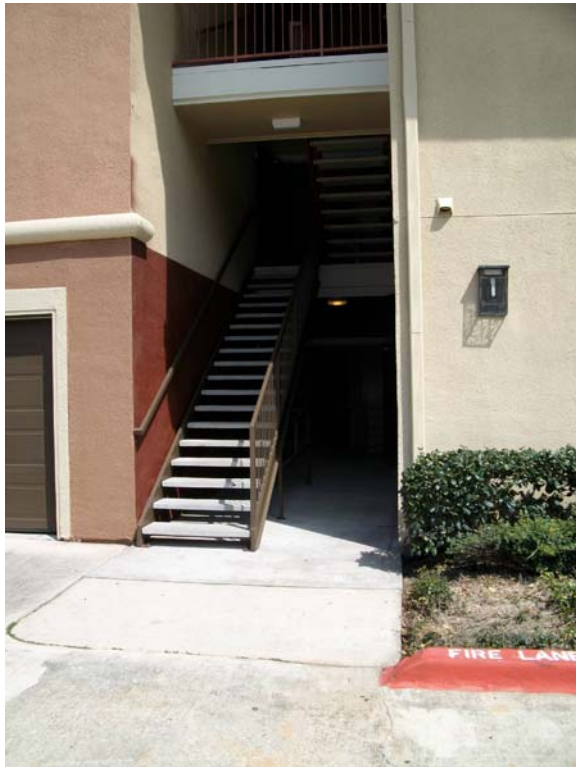
Bldg 8, Left Breezeway Entry (#S0161)

The left breezeway had a sidewalk that extended straight out to the drive lane and curved around along the side of a parking space behind the garages. There was no detectable warning at the blended transition to the parking space or to the vehicular lane.

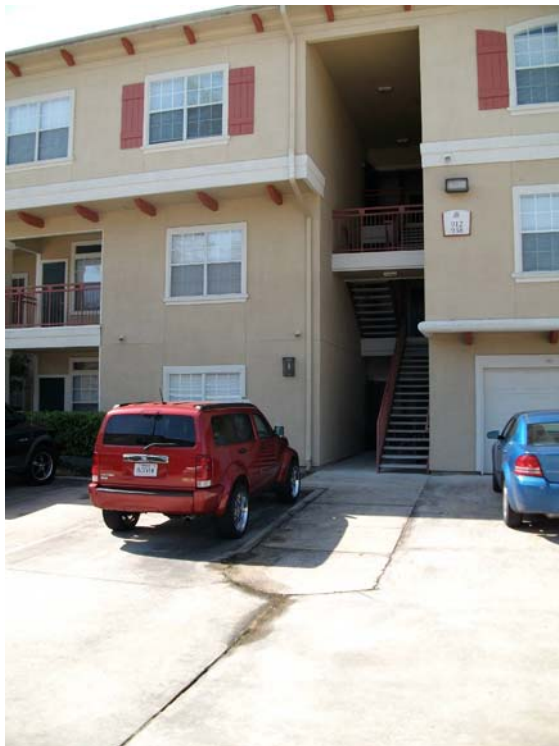
Bldg 9, Right Breezeway (#S0094)

The right breezeway had a sidewalk that extended straight out to the drive lane and opened on the right to parking behind the garages. There was no curb ramp or detectable warning at the blended transition to the parking space or to the vehicular lane. The running slope at the sidewalk was 8.7% which was more than the 8.33% maximum running slope allowable for ramps (ANSI 4..3.7).

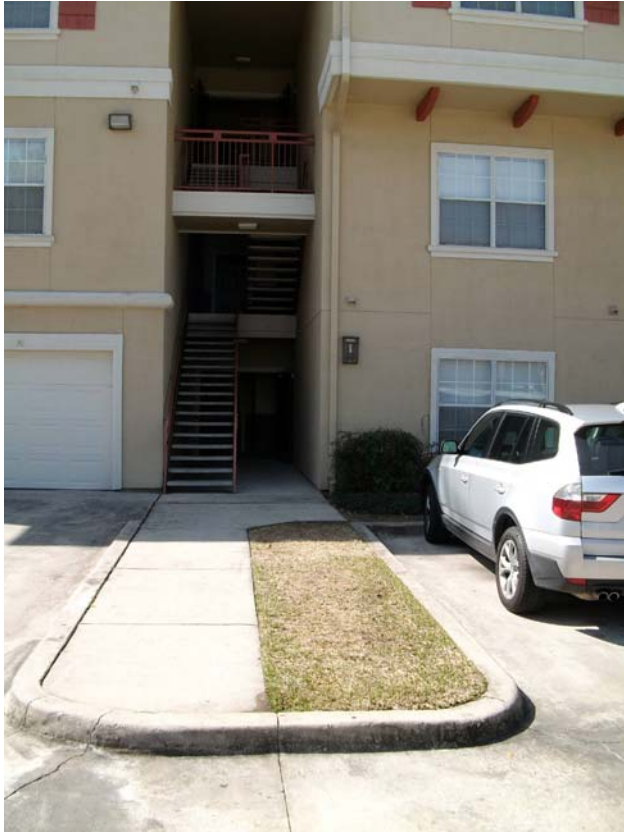
Bldg 9, Left Breezeway Entry (#S0115)

The left breezeway had a sidewalk that extended straight out to the drive lane and a curb. At one side, the breezeway ended at a parking space behind the garages. There was no detectable warning at the blended transition to the parking space nor was there a curb ramp or detectable warning at the curb at the vehicular lane.

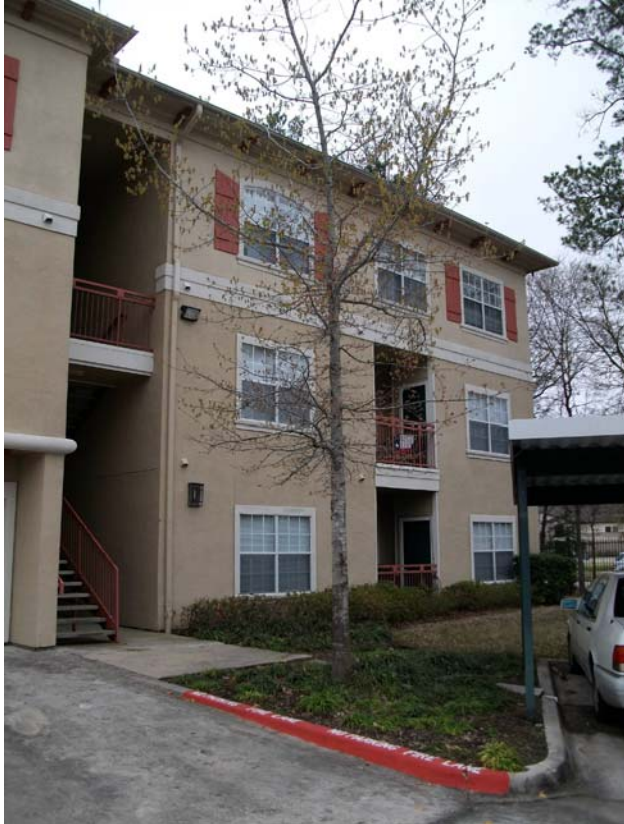
Bldg 10, Right Breezeway (#S0008)

The right breezeway had a short sidewalk open to parking behind the garages. There was no curb ramp or detectable warning at the blended transition to the parking space. There was no sidewalk beyond the side of the parking space.

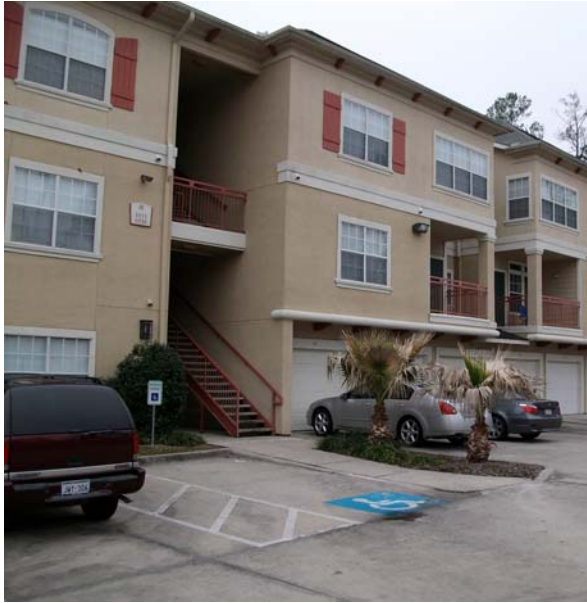
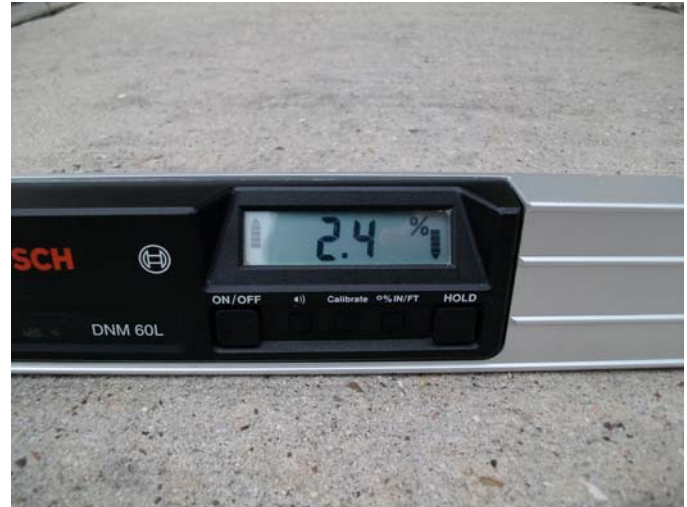
Bldg 10, Left Breezeway Entry (#S0006), left Level at Curb Ramp (#S0024) , above

The left breezeway had a sidewalk that extended straight out to the drive lane. At one side, the breezeway opened to parking behind the garages. At the other side, the walk sloped down to the level of the accessible parking space. There was no detectable warning at the vehicular lane. The cross slope at the curb ramp/blended transition was more than 2% (2.4%) (ANSI 4.3.7).

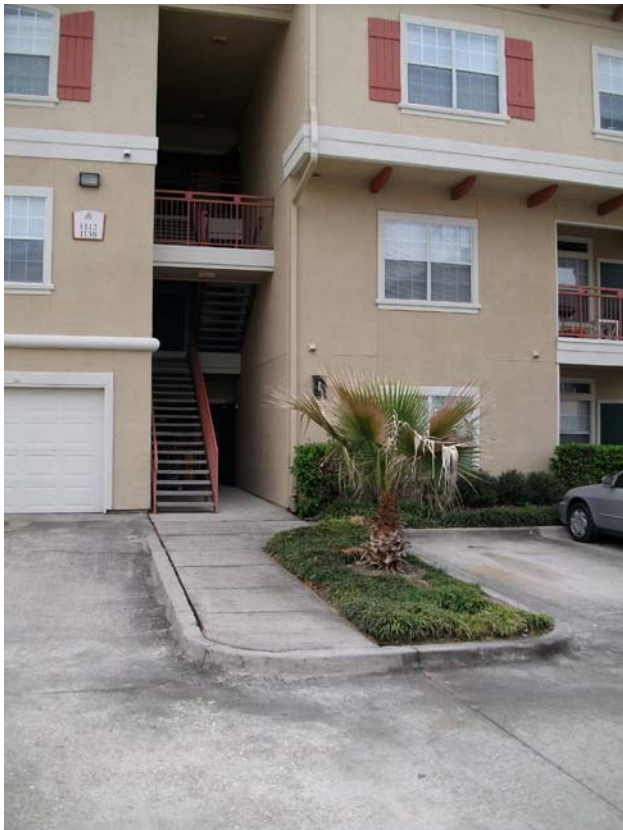
Bldg 11, Right Breezeway Entry (#S0069)

The right breezeway had a sidewalk that extended straight out to the drive lane and a curb. At one side, the walk ended at a parking space behind the garages. There was no detectable warning at the blended transition to the parking space nor was there a curb ramp or detectable warning at the curb at the vehicular lane.

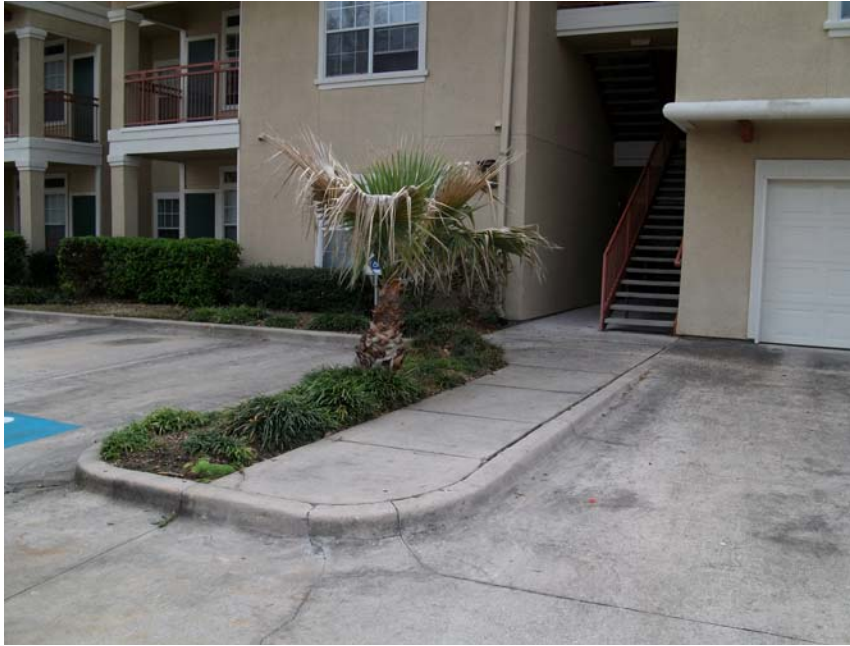
Bldg 11, Left Breezeway Entry (#S0079)

The left breezeway had a sidewalk that extended straight out to the drive lane and a curb. At one side, the walk opened to a parking space behind the garages. There was no detectable warning at the blended transition to the parking space nor was there a curb ramp or detectable warning at the curb at the vehicular lane.

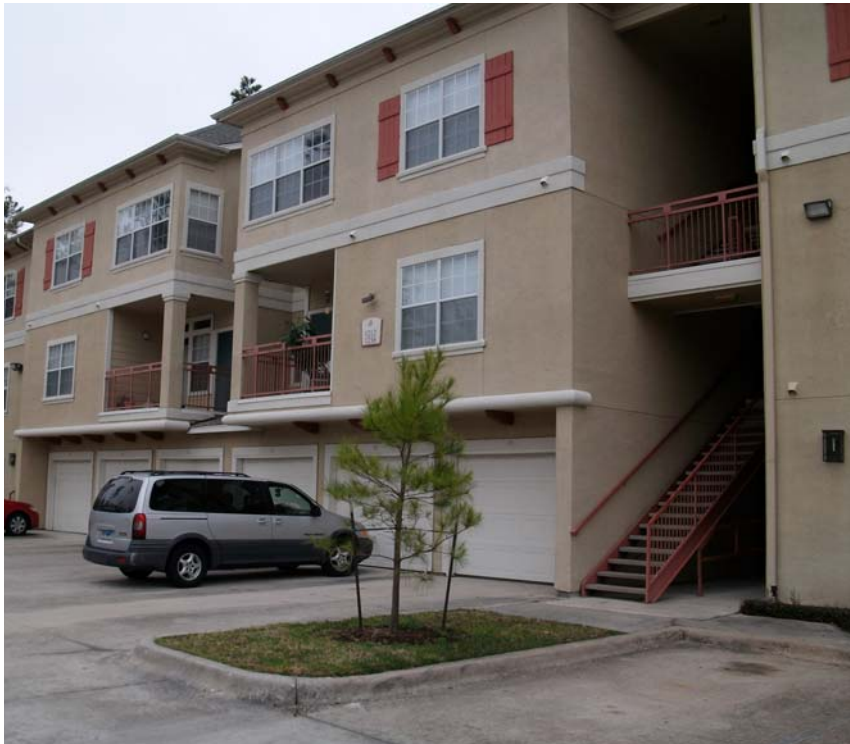
Bldg 12, Right Breezeway Entry (#S0034)

The right breezeway had a short sidewalk that connected with a blended transition to an open parking space behind the garages on the left side and to a curb at another parking space on the right side. There was no detectable warning at the blended transition to the left parking space and no curb ramp to the parking on the right.
